**SEISMIC RETROFITTING
OF
OFFICE BUILDING OF WARD NO. 3
OF
BIRATNAGAR SUB-METROPOLITAN CITY, MORANG, NEPAL**

Progress Report No.2

(From 16th December 2009 to 15th January 2010)

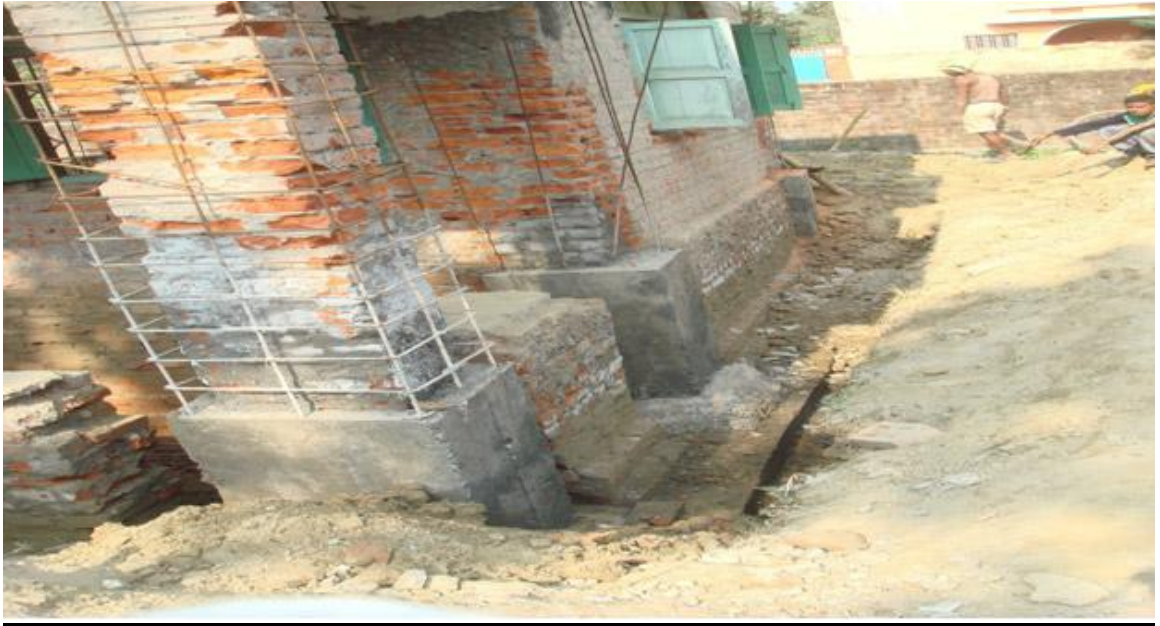
Laying of Reinforcement for Splints

Tor Steel reinforcement works for tie beam of the building have been completed. Similarly, reinforcement works for splints is complete at out side and that at inner side is on progress inside.

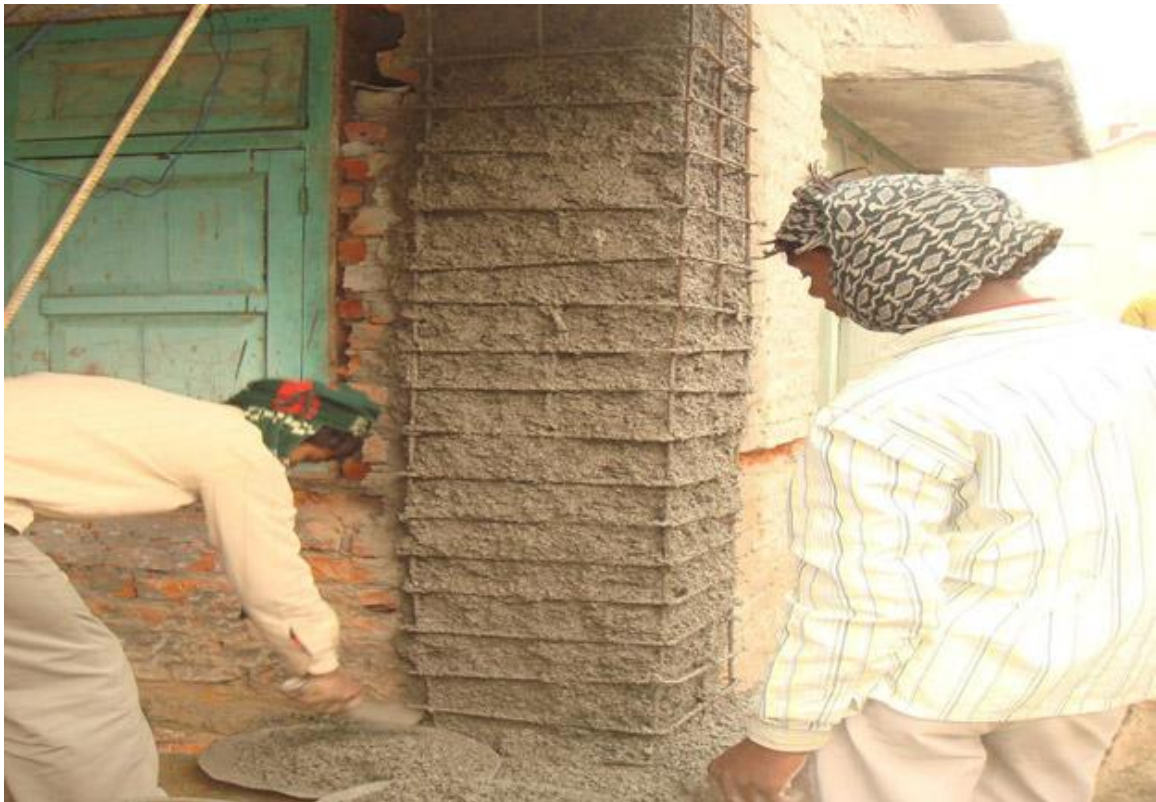
Micro- Concrete Work in Progress

Micro concrete works of the splints up to plinth level has been completed.

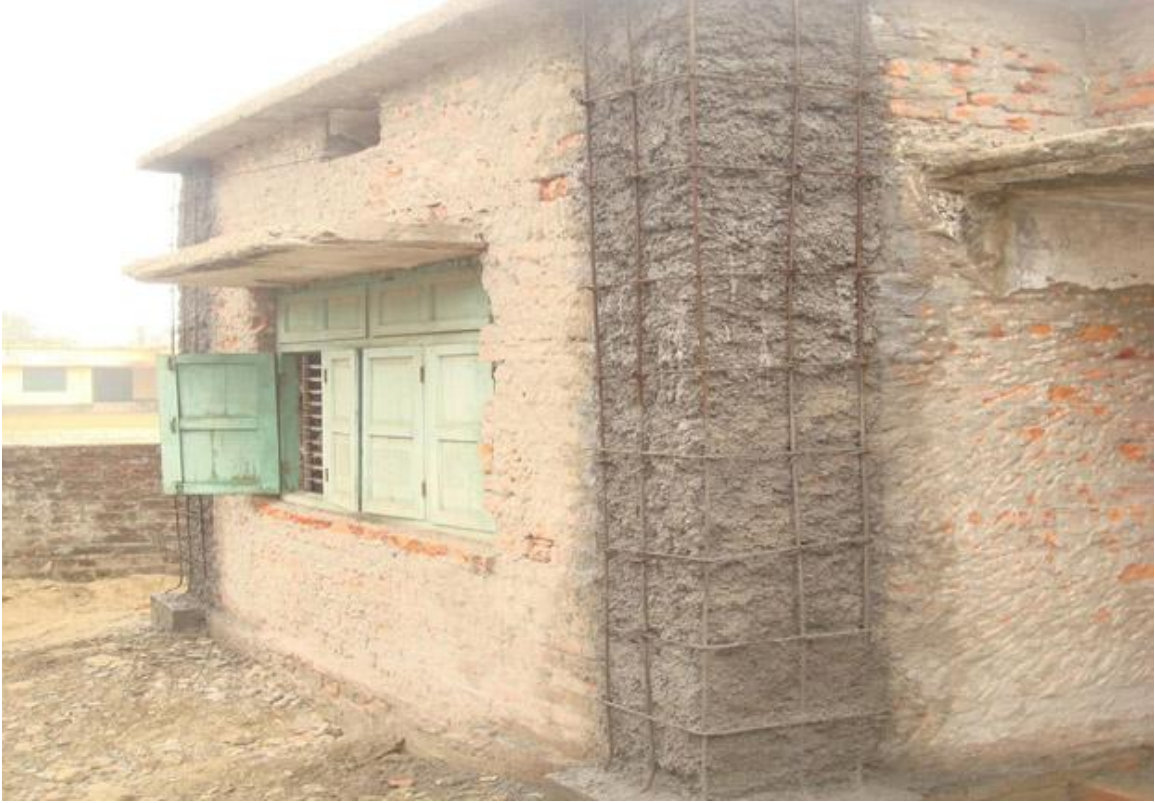
First Coat of Micro- Concrete

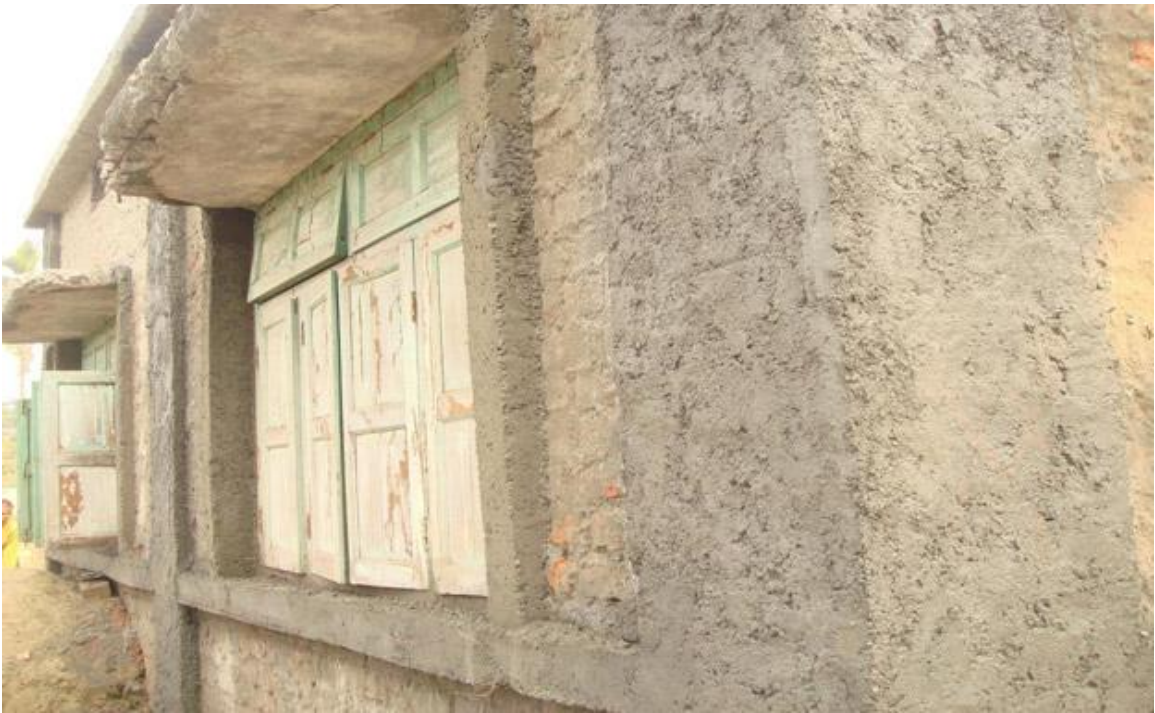
Splint and Bandage

Stitching bars were driven into the walls for the anchorage of splints and tie beams as per specifications.

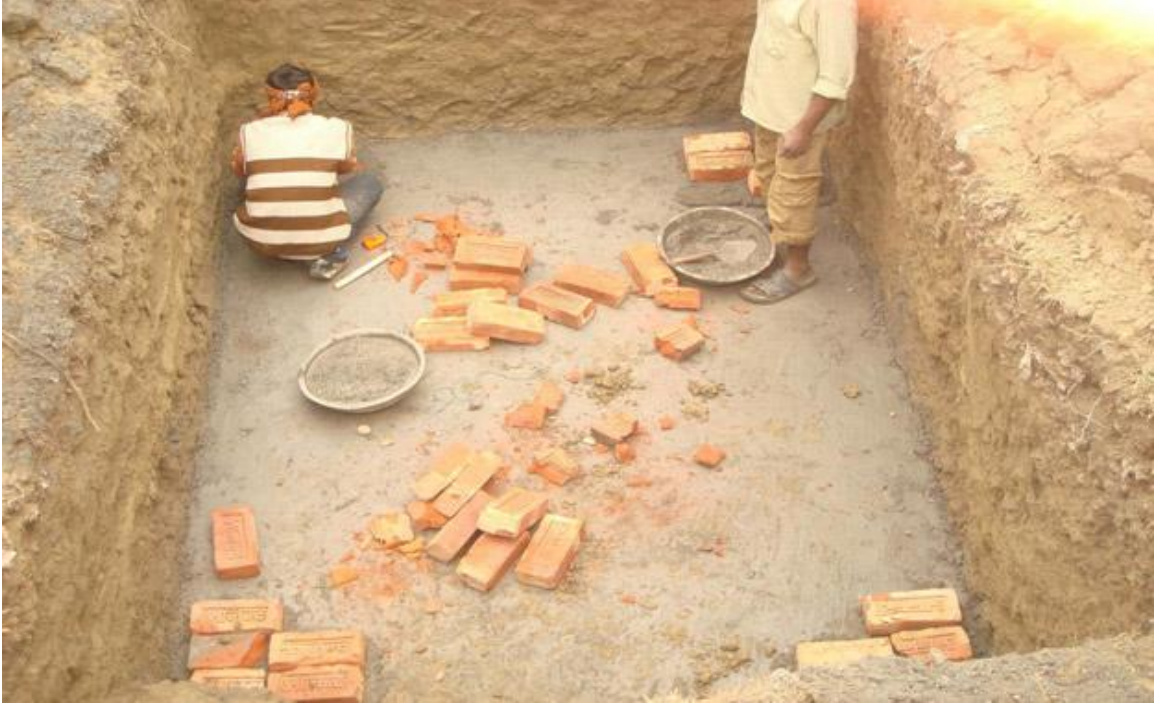
Excavation for Septic Tank

Excavation for septic tank is completed. Flat brick soling and P.C.C(1:2:4) is also completed. Brick work is in progress.

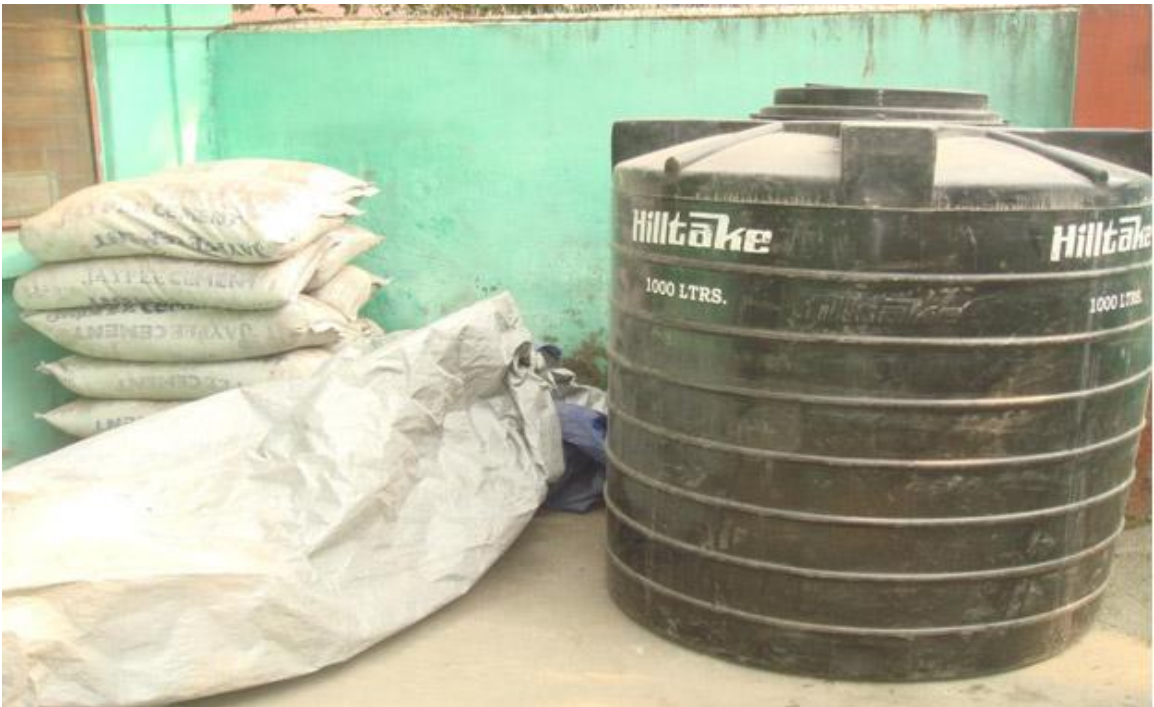
Dumping of Cement and Water Tank
